The December 2020 rock-ice avalanche at Punta S. Matteo (Ortles-Cevedale Group, Italian Alps)

The rock-ice avalanche

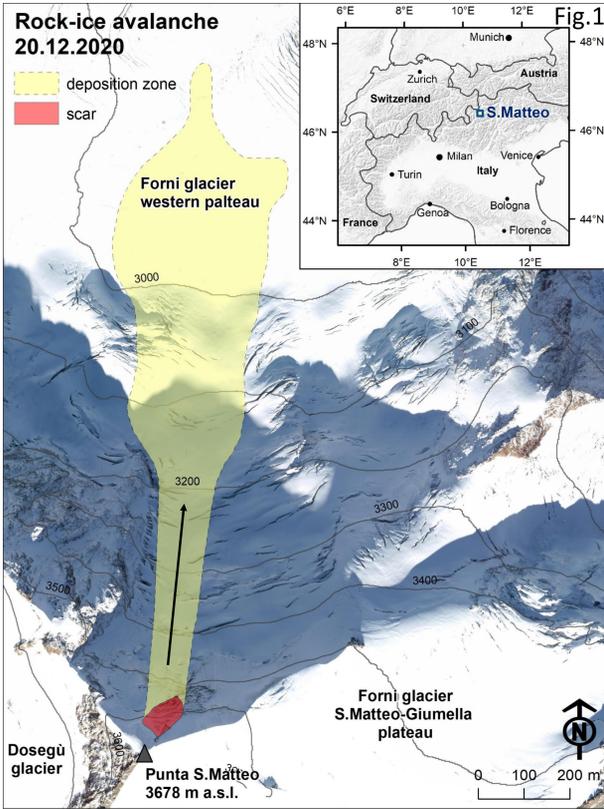
Fig. 1. Location of the rock-ice fall scar and the deposition zone (ortophoto AGEA 2018 – accessed through WMS service of Regione Lombardia)
Fig. 2. The Forni glacier and the P.ta S. Matteo (ph. Riccardo Scotti)
Fig. 3. The rock-ice fall scar highlighted (a) before the event and (b) after from Branca Hut (ph. Riccardo Scotti)
Fig. 4. Aerial view of the north-slope of Punta S. Matteo after the rock-ice fall event (ph. Marco Confortola)

Between 19 and 20 December 2020 a rock-ice avalanche detached from the northern side of Punta S. Matteo (3678 m a.s.l. – Upper Valtellina – Italian Alps) travelling along the steep glacier-covered northern slope of the mountain and stopped on the western plateau of Forni glacier at 2945 m a.s.l.. The scar ranges in elevation from 3535 to 3650 m a.s.l. and a preliminary estimation of its depth (~ 10 m with maximum values of 25-30 m) was crucial in quantifying the event volume (~ 87000 m³). The avalanche was composed by 90% of rock (phyllite) and 10% of glacier ice and firn that used to cover part of the detached bedrock. The deposition zone covers a surface of 255.000 m² with a maximum runout of 1.4 km (Figs. 1-4).

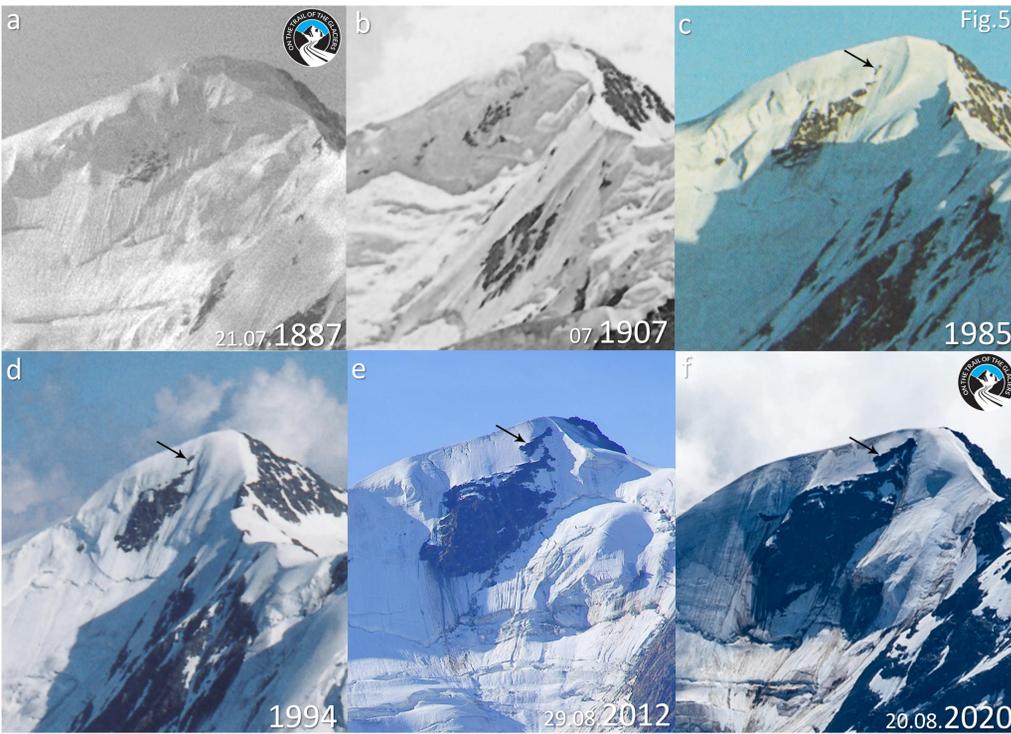
Fig. 5. Evolution of the northern slope of Punta S. Matteo (a) 1887 Vittorio Sella – © Fondazione Sella onlus; (b) 1907 Alfredo Corti – Archivio Corti – CAI sez. Valtellinese www.archiviocorti.it; (c) 1985 Antonio Galluccio – Arch. SGL; (d) 1994 Jacopo Merizzi – from the book «aria di valtellina»; (e) 2012 Gionata Neri – Arch. SGL; (f) 2020 Riccardo Scotti – © Associazione Macromicro. The black arrow points at the rock outcrop located at the top of the rock-ice fall scar

Our speculation about the possible failure triggering factors focuses on the glacial history of the site. At least since the Little Ice Age, most of the depletion zone was covered by glacier ice until 1980-1990 when, due to glacier thinning, a major rock outcrop started to appear in its upper portion (Fig. 5). Given both elevation and aspect, the small portion of the depletion zone that was not covered by ice, at least since the end of the XIX century, was likely in permafrost conditions with probable cold ice in the surroundings. In the last 30 years, without the ice layer protecting the rock wall and due to the increase in availability of both meltwater and summer rainstorms, water circulation in rock discontinuities significantly increased. Moreover, the intensification in water percolation and refreezing in both firn-ice cover and bedrock could have enhanced latent heat dissipation and permafrost warming (Fig. 7). This transition could have triggered various possible mechanisms of rock mass deformation until the final collapse.

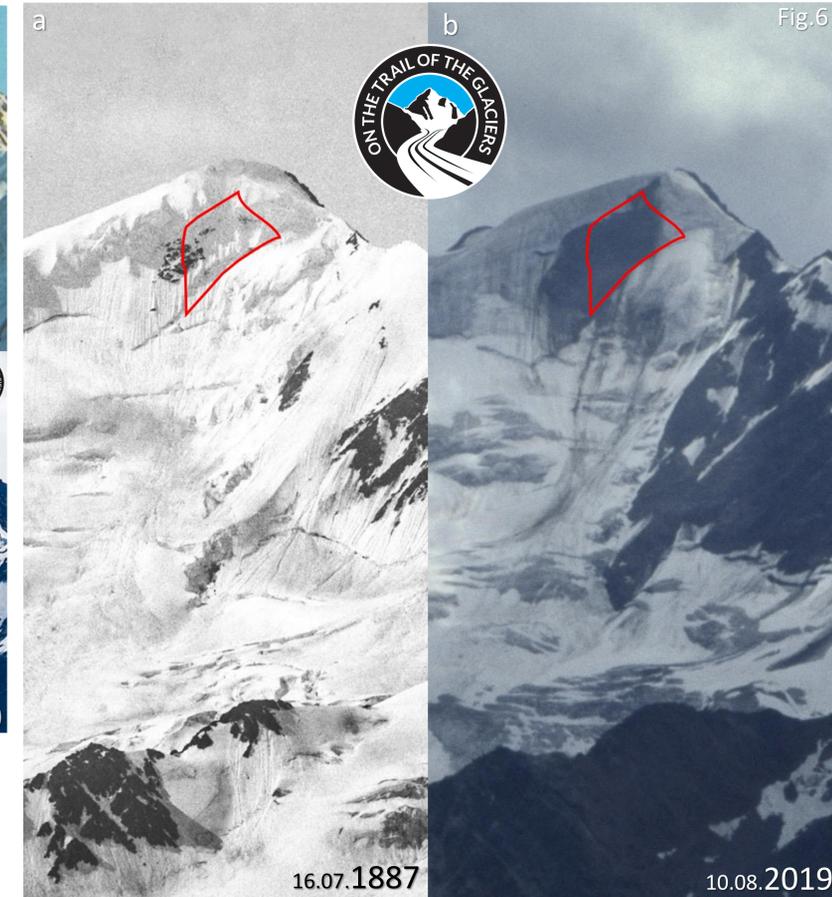
Fig. 6. The northern slope of Punta S. Matteo in (a) 1887 Vittorio Sella – © Fondazione Sella onlus; 2019 Fabiano Ventura – © Associazione Macromicro – www.sulletraccedeighiacciai.com. The December 2020 rock-ice fall scar surface is highlighted in red

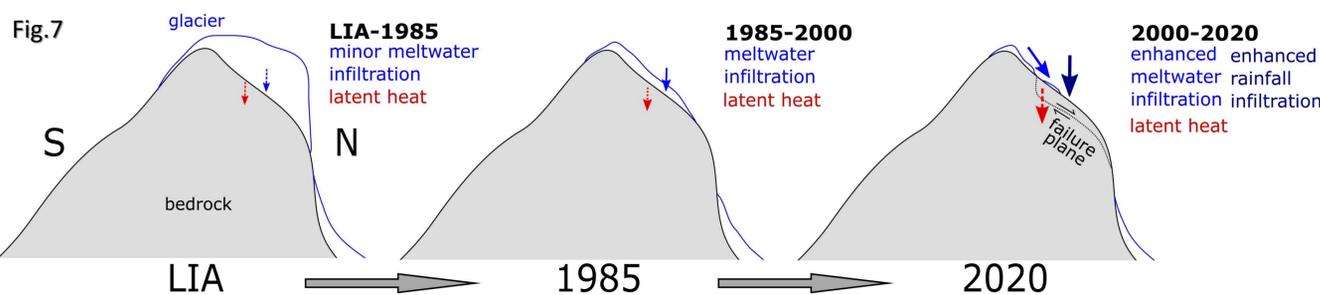
Fig. 7. Conceptual scheme of the evolution of both the glacier cover and the possible thermal perturbations at the ice-rock interface at Punta S. Matteo. Modified after: Huggel, Christian. "Recent extreme slope failures in glacial environments: effects of thermal perturbation." Quaternary Science Reviews 28.11-12 (2009): 1119-1130

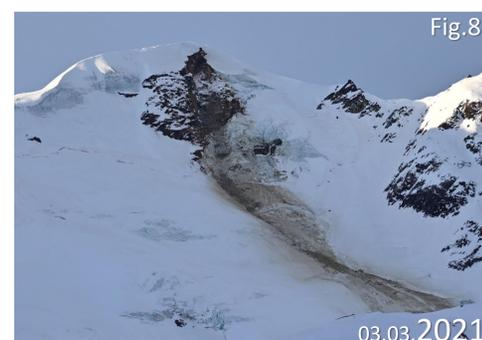
Fig. 8. The March 2 event (ph. Fausto Compagnoni)
Fig. 9. Upper part of the scar with highlighted portions of rock and ice collapsed between December 23, 2020 and February 4, 2021. (a) ph. Riccardo Scotti and (b) ph. Marco Maurizio Foffano

In the three months following the major event, other minor rock and ice falls occurred (Fig. 9) until March 2, when another significant rock portion broke off from the central section of the original scar (Fig. 8). In the next few years, if the destabilization phase will cease, despite the ongoing climate warming trend that caused the progressive de-glaciation of the rock wall, given the after-event deep concave morphology of the upper portion of the scar, is it possible that enhanced windblown snow accumulation would lead to a partial re-glaciation of the site.
